# SANDIA REPORT

SAND88-2902 • UC-70

## **Analysis of the Accidental Explosion at Pepcon, Henderson, Nevada, May 4, 1988**

Jack W. Reed

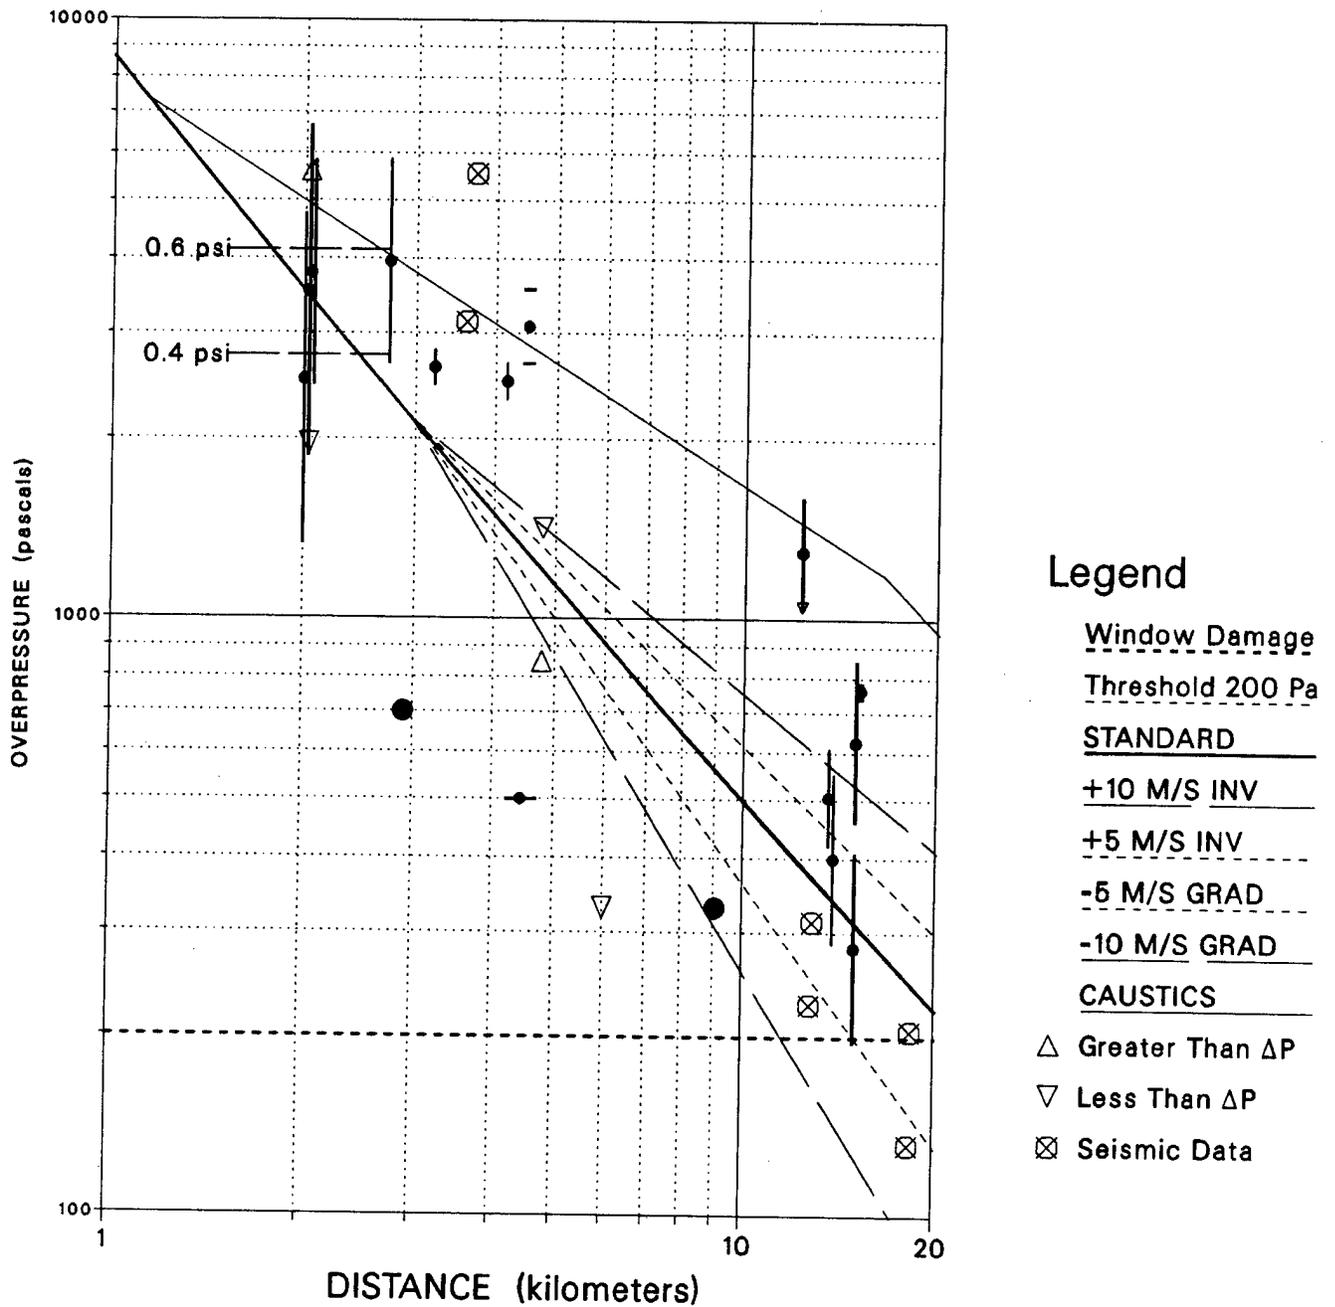
Notes from a two-day survey of damages in Henderson and Las Vegas have been included in Appendix A. Since TTU surveyors reported considerable detail on their tape recorders, only relatively few, seemingly striking or important features were written down by this author. These have been interpreted, through use of Figures 5 through 8, as estimated overpressure-distance values shown in Figure 10. Interpretive details are listed in Tables 9 and 10.

East of PEPCON, Henderson residences extend to Albany Way, at 2.9 km where only about one broken window per house appeared to result from around 700-Pa overpressure, shown by a large solid circle in Figure 10. Visibility was limited in this older community, however, with high walls and trees obscuring likely additional damaged panes. Near Crest and Buchanan Streets, at 3.21 km, conversation with a resident disclosed 6 broken of 16 exposed SS panes; all were double-pane insulating windows. This inferred around 2600-Pa overpressure, in closer agreement with the Standard curve.

In summary of these spot damage interpretations in Figure 10, the cloud of data does generally surround a 1-kt NE Standard curve, reinforcing the initial estimate that the largest PEPCON explosion was about equivalent to 250 tons, possibly 500 tons, of chemical high explosives. But ammonium perchlorate is "not detonable", so there are no federal, state, or OSHA standards for treating and handling it as such, nor TNT equivalences for estimating how much AP actually exploded.

Figure 10. Airblast overpressure versus distance curves for 250-ton TNT surface burst at PEPCON, with data estimated from damage evaluations. (Vertical bars indicate range of overpressures needed to give observed damage probabilities).

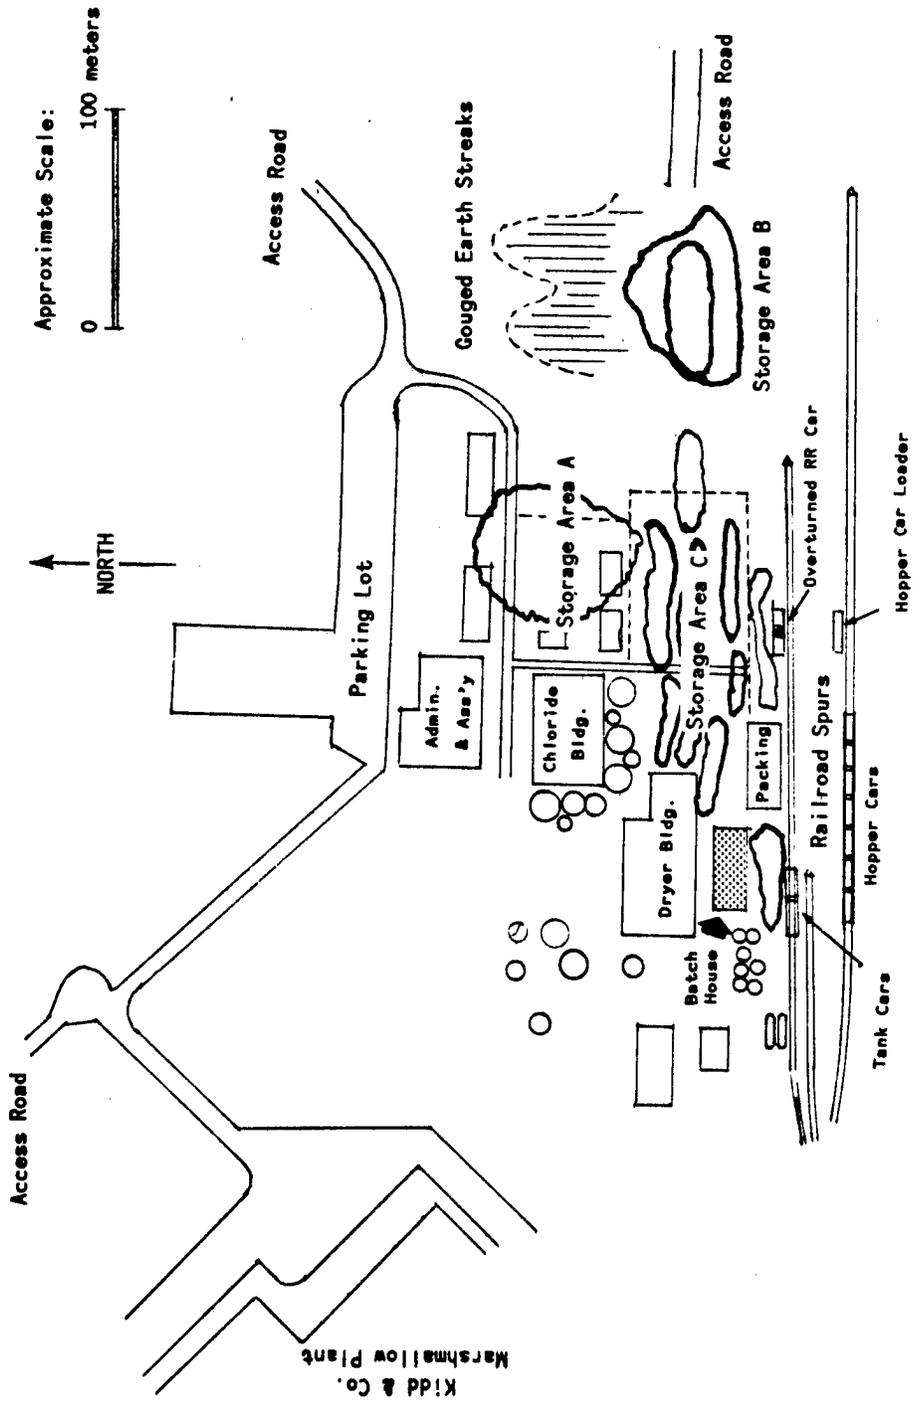
Aerial photography was flown over the PEPCON region by EG&G, instrumentation contractors to DOE-NVO, on May 10, 1988. The expectation was that an explosion crater could be dimensioned as an additional yield estimator. Since there was no clear crater formation comparable to ones observed after point explosion tests, no yield scaling was possible. Their photographs did assist in estimating what happened, however, as well as help clear up some map scaling problems that were encountered in connecting the Henderson map in Figure 9 to the Las Vegas map in Figure 11. A sketch of the PEPCON facility in Figure 12, annotated with help from newspaper stories in Appendix B, shows where the initial fire broke out of control in the Batch House, then spread to the Dryer Building and on to the Chloride Building. It is not clear where the first large explosion occurred. What is obvious from these aerial photographs is that the latest and largest explosion occurred in Storage Yard B, nearly 300 m east of the Batch House.

Although it is not important to analysis of damage, overwhelmingly caused by the largest explosion, it might appear that the first explosion occurred at the Batch House and a small adjacent storage area. The east end of the Batch House appears to have been blown away. The second, dark explosion could have been a relatively low-order detonation of the 607-Mg AP in Storage Area A.

Figure 12. Sketch map of Pacific Engineering Company (PEPCON), Henderson, Nevada, with primary explosion damage features.
